Manhole Inspection Summary

Manhole # S31A__006MH

Location Address: **628 DRUID HILL AVE**

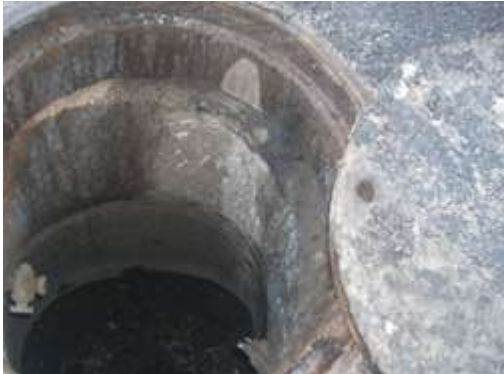
Defect 3

Condition: ☐ Sound ☐ Cracked ☐ Root Intrusion ☐ Loose Brick ☒ **Deteriorated**

Infiltration: ☐ None ☐ Joint ☐ Cracks ☐ Mortar ☐ Roots ☒ **Wall**

CHIMNEY INFILTRATION AND
DETERIORATION

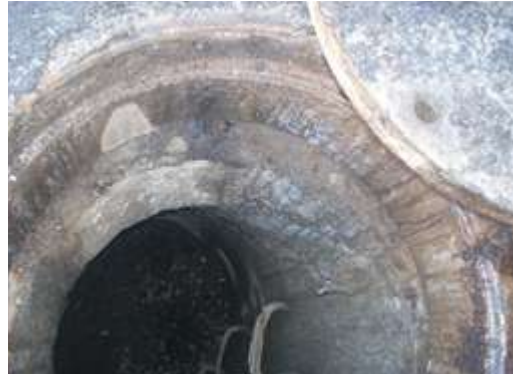
Defect 1

Offset: **2** (in.)

FRAME OFFSET

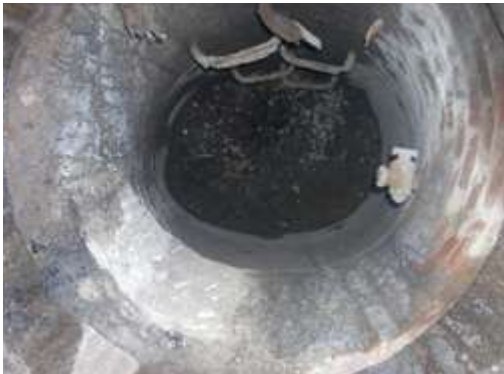
Defect 2

Count: **4** Missing: **1** ☒ **Corroded**

MISSING AND CORRODED STEPS

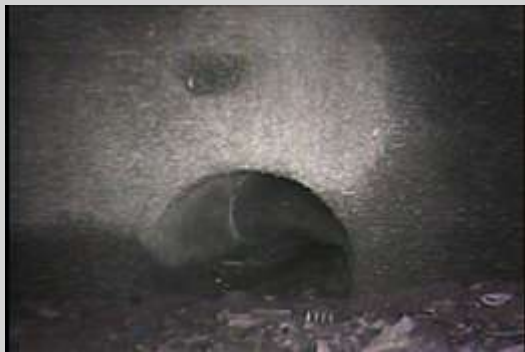
12 O'Clock Outflow

8 in. Circular Gravity Sewer
Pipe Out @ 12 O'Clock

Deposits: ☐ None ☒ **Mud** ☐ Sludge ☒ **Debris** ☐ Grease

Silt Depth: **3** (in.) Deposits Extent: **Medium**
